DEPARTMENT OF TRANSPORTATION

Contract #: 04-0120F4Cty: SF/ALA Rte: 80 PM: 13.2/13.9File #: 1.28**WELDING INSPECTION REPORT****Resident Engineer:** Casey, William**Address:** 333 Burma Road**City:** Oakland, CA 94607**Report No:** WIR-026520**Date Inspected:** 14-Oct-2011**Project Name:** SAS Superstructure**OSM Arrival Time:** 700**Prime Contractor:** American Bridge/Fluor Enterprises, a JV**OSM Departure Time:** 1530**Contractor:** American Bridge/Fluor Enterprises, a JV**Location:** Job Site

WELDING INSPECTION REPORT

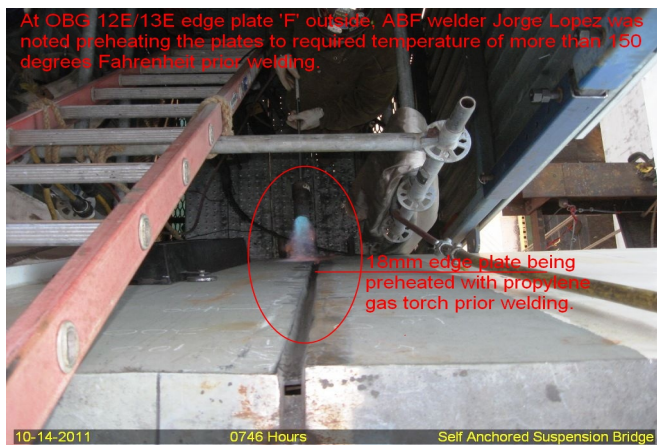
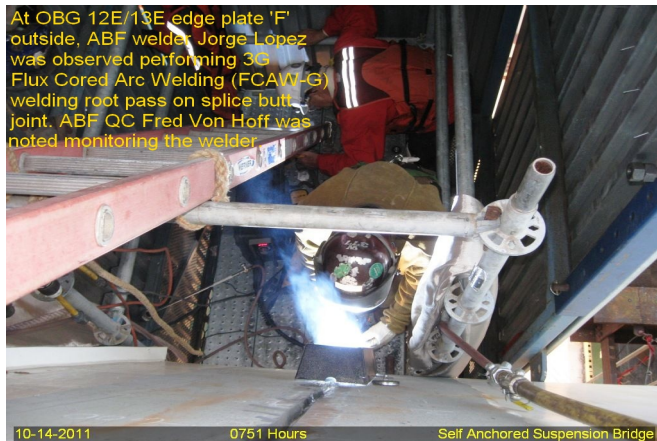
At OBG 12E/13E edge plate 'F' outside, QA randomly observed ABF/JV qualified welder Jorge Lopez continuing to perform fill pass welding on the Complete Joint Penetration (CJP) splice butt joint. The welder was observed manually welding in the 3G (vertical) position utilizing a dual shield Flux Cored Arc Welding (FCAW-G) with E71T-1M, 1/16" diameter wire electrode implementing Caltrans approved Welding Procedure Specification (WPS) ABF-WPS-D15-3040B-3. The joint being welded has a single V-groove butt joint with steel backing bar. ABF Quality Control (QC) Fred Von Hoff was noted monitoring the welding parameters of the welder. QA randomly monitored the welding parameter with readings of 240 amperes, 24.5 volts and 170mm per minute with calculated heat input of 2.08 Kjoules per mm. travel speed which appears in conformance to the contract requirements. During the shift, FCAW fill pass welding was still continuing when the job was turned over to fellow QA William Clifford due to another job assignment at Pier 7.

At Pier 7 Oakland, CA, this QA randomly observed ABF/JV qualified welder Kevin Kunanen ID #6521 perform 2F fillet welding between the Seismic Performance Critical Members (SPCM) top of Cross Beam #19 to 1 1/2" thick lifting eye and its four (4) stiffener plates. The welder was noted using Shielded Metal Arc Welding (SMAW) with 5/32" diameter E7018H4R electrode implementing Caltrans approved Welding Procedure Specification (WPS) ABF-WPS-D15-F1200A. ABF QC Salvador Merino was noted monitoring the welder's welding during welding. Prior welding, the welder was noted grinding off the paint coating where the lifting eye

will be installed. The welder used the acetylene gas torch to preheat the lifting eye and the cross beam base plate to the required temperature of more than 150°F. This QA measured the welding parameter during welding and was noted 185 amps on the 5/32" diameter E7018H4R electrode and verified the preheat using the Fluke Infra Red Thermometer. Welding parameters noted appear in compliance to the contract requirements. At the end of the shift, fillet welding of 5/16" all around the lifting eye and its four (4) stiffener plates was completed but was not able to clean the welds due to limited time. QA was then informed by ABF QC Salvador Merino that the Visual Test (VT) and the Magnetic Particle Inspection (MT) to the welded 5/16" fillet weld will be done tomorrow.
